Year 2 Evaluation
Wetlands Report

Dundonnell Brolga
Compensation Plan

9 December 2022

To provide the Year 2 wetland monitoring report as required by the endorsed Dundonnell Wind Farm Brolga Compensation Plan (BCP), under Condition 55b of Planning Permit No. 2015/23858.

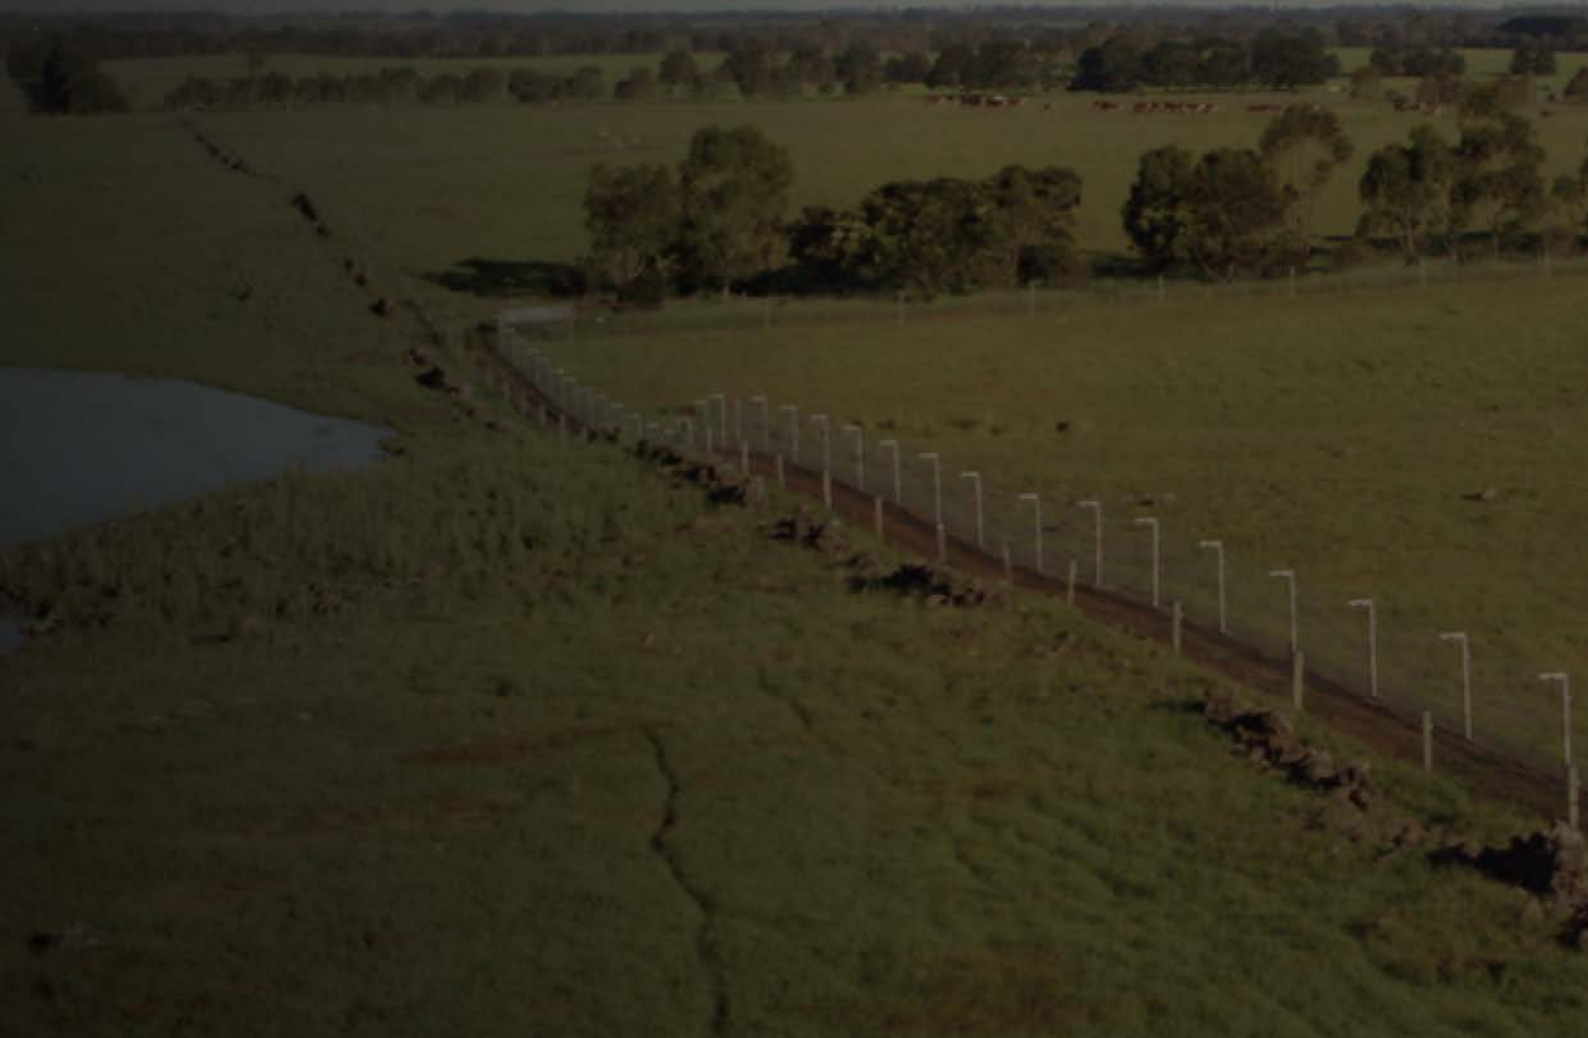
Photo 1. DUN001 Wetland with the geo-fabric sandbags installed (October 2022)

Year 2 progress of DUN001 has seen a robust drain block implemented using a combination of soil and Geofabric sandbags, ensuring sandbags made up at least 60-70% of the drain block. A solid base was made using existing onsite soil taken from a nearby soil mound (historical dam excavation). A removable capping of geo-fabric sandbags was used across the 40m section of the drain. The block was made to the recommended sill height of 0.95m above the bottom of the dam (obtained from hydrology assessment completed by Nature Glenelg Trust). The use of removable geofabric sandbags will allow adjustment to water height if required.

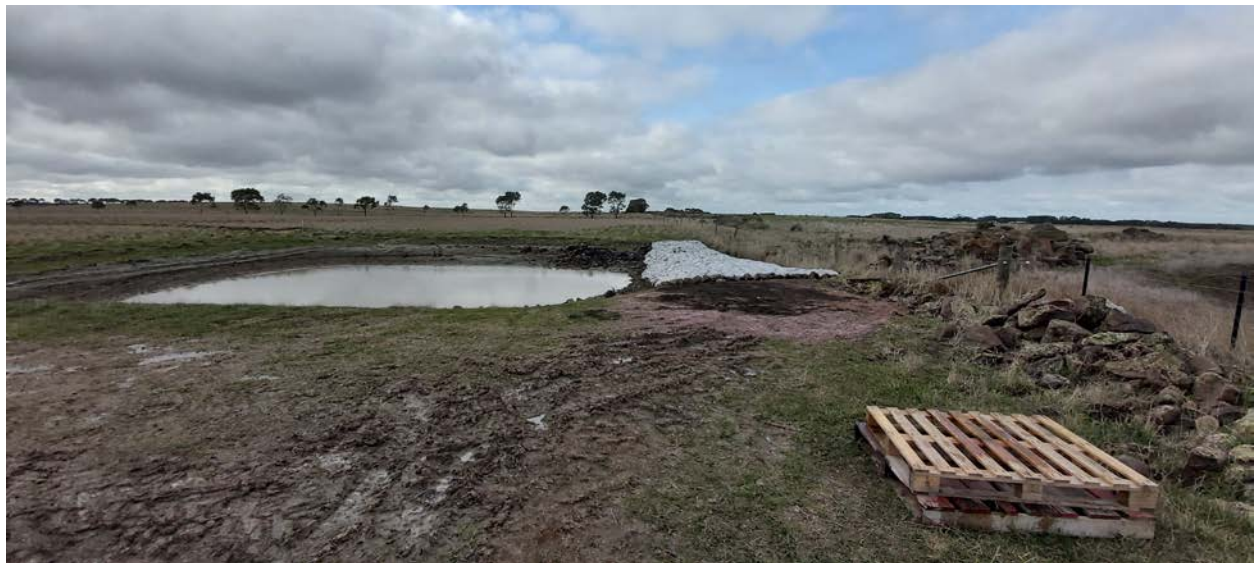
Photo 2. Finished sandbagging at wetland drain.

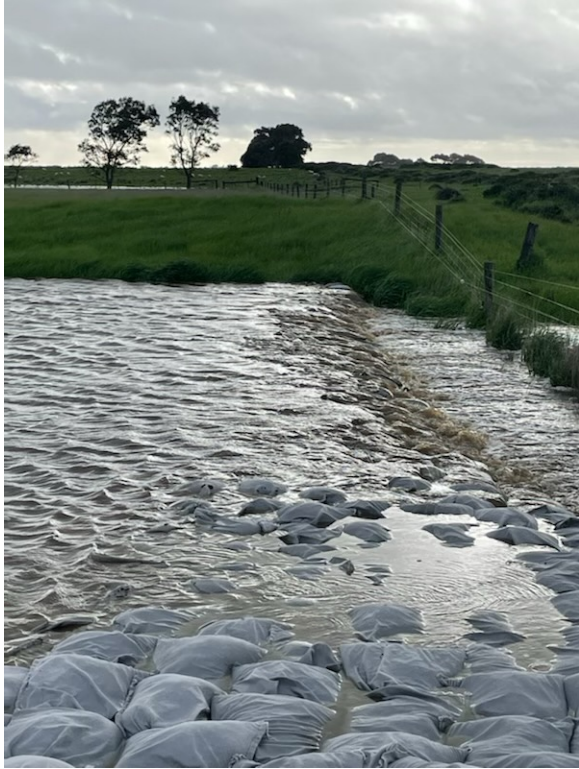
The geo-fabric sandbags which were placed 11th May 2022 to block the drain and reinstate the wetland, held up well with 70ml of rain falling 13th October 2022 resulting in floodwaters passing through and over the sandbags. Inspection during monitoring has recorded the bags are still secured in place.

Photo 3. Installed sandbag block after 70ml of rain in October 2022

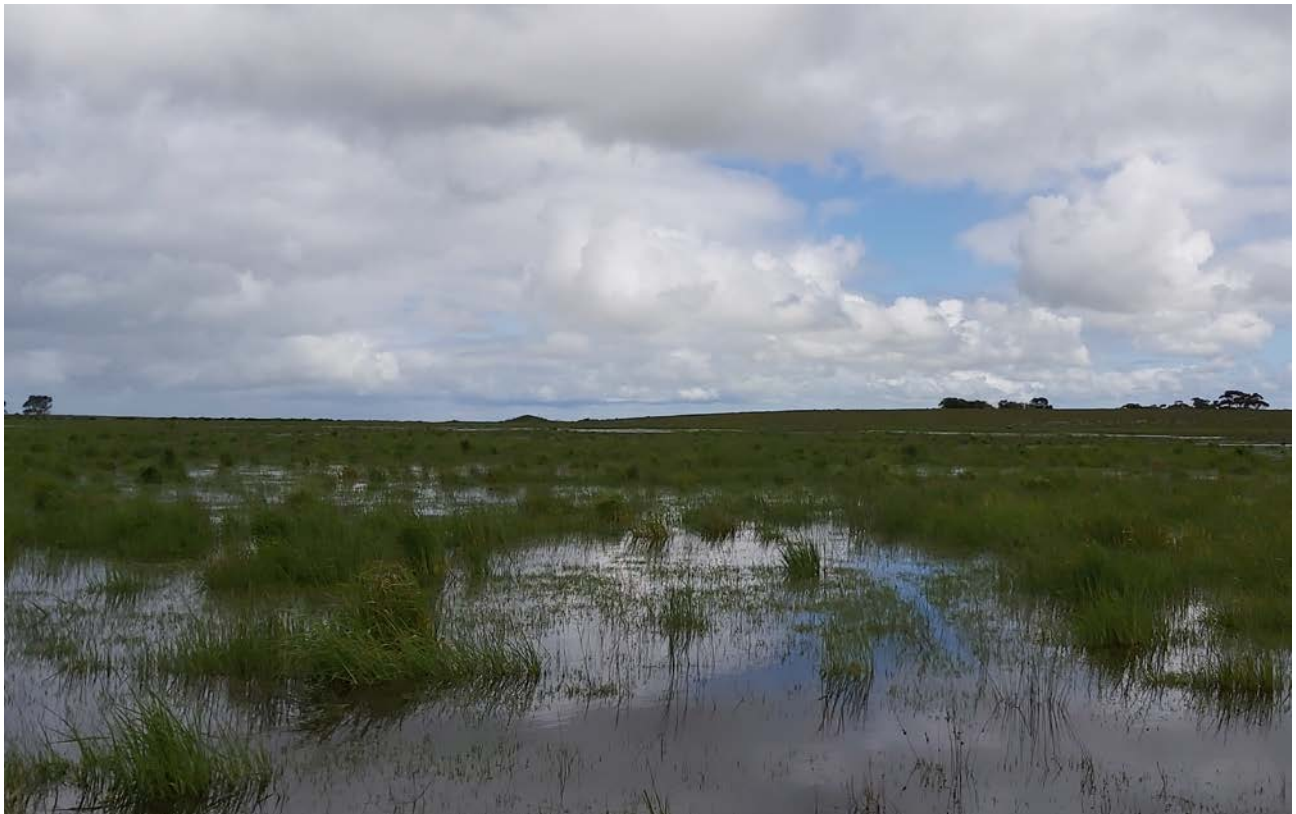
The final monitoring for the 2021 season occurred on 30th November 2021 due to the sandbags giving way and the water dispersing through the drain. The sandbags used degraded quickly from the sun and rain, along with the large volume of water being held back they gave way under the pressure. Appendix 5 provides a full list of depth post records. No water was then recorded at the wetland until 19th October 2022. The wetland extent was recorded by walking around the wetland and tracking marks through a handheld GPS (Appendix 6). This was then used with the Digital Terrain Model (DST-Lidar) to provide an assessment of the percent coverage of water at or above 30 cm within the water depth and duration map in Appendix 7. *The BCP wetland performance target is to re-establish the required inundation regime of a minimum of 30 cm inundation of 75% or more of the wetland basin for more than a full Brolga breeding event.* The wetland in October 2022 reached almost 50% inundation of 30cm or more across the basin and is currently at 40% for November 2022.

Photo 6. Wetland in October 2022

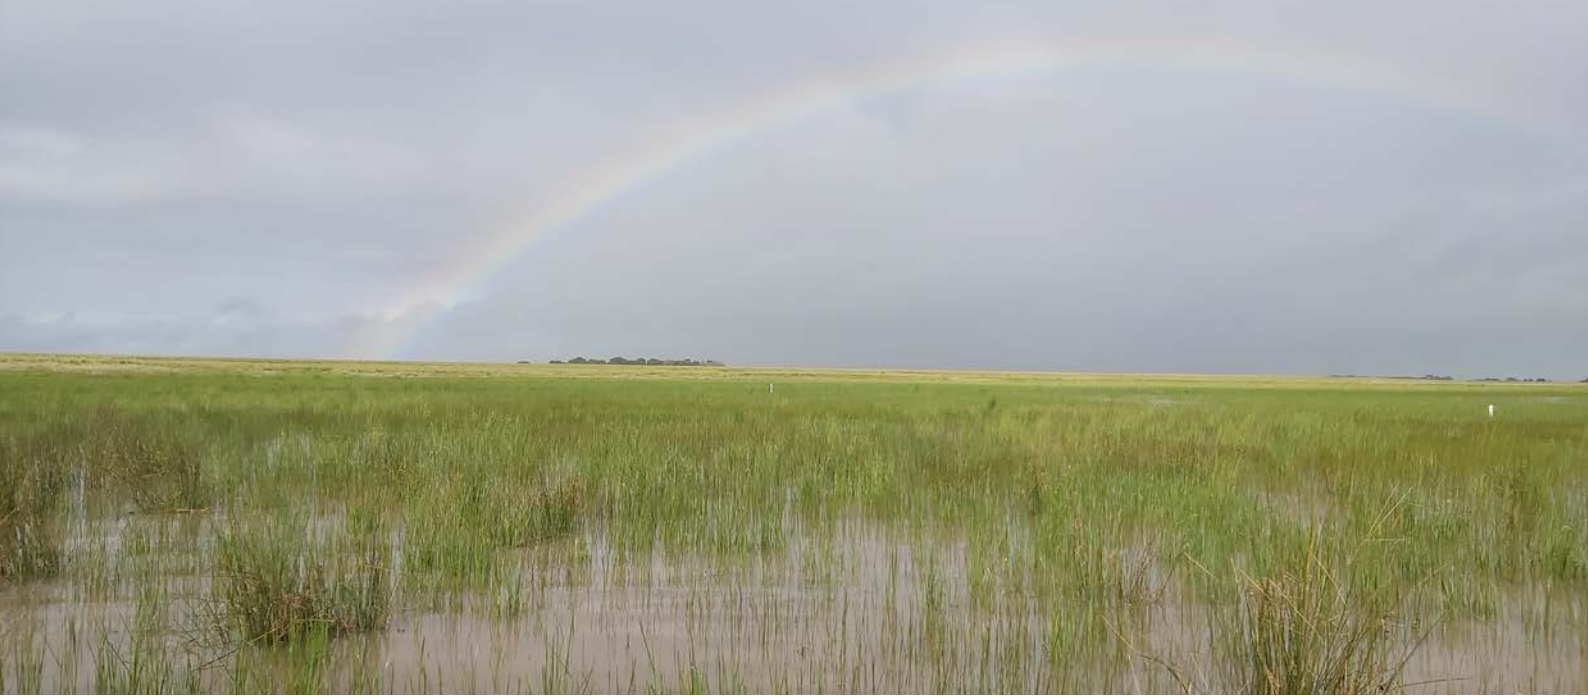
Photo 7. DUN002 Wetland (November 2022)

A temporary block using sandbags was installed at the wetland outlet in Year 1, due to a high volume of water the bags degraded quickly and existing soil and rock from the original excavations were pushed back over the sandbags into the drain. This has provided a better barrier to restrict water flow to the original sill level. The drain block is working well and hasn't required further maintenance. During site visits Greening Australia staff observed a pair of Brolgas on numerous occasions including:

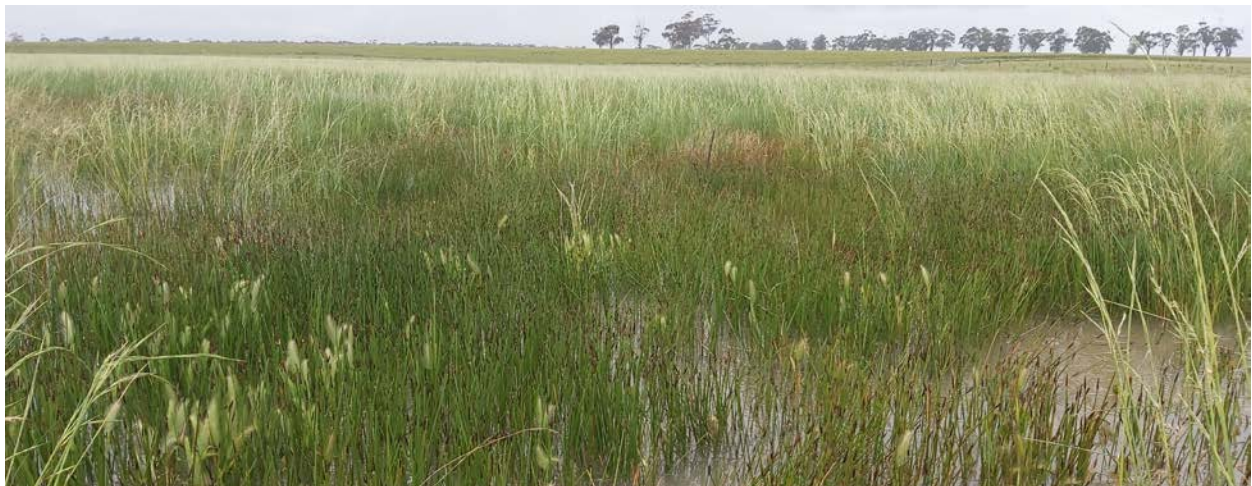
Using the DST v1 method along with four permanent 120m transect lines, vegetation was assessed in December 2020 and again in December 2021. Four permanent transects were surveyed prior to the wetland restoration and again in December 2021 to determine extent of native aquatic vegetation to meet the BCP wetland performance targets, this being '*at the end of the second wetland filling there is to be 80% or greater aquatic vegetation cover over 40% of the wetland basin within two fillings*'. The aquatic vegetation cover in December 2020 was 19% (native grasses only), the following survey in December 2021 increased native grass, sedges and rushes to 86% cover.

Photo 10: Aquatic vegetation *Eleocharis*, *Glyceria* and *Amphibromus*

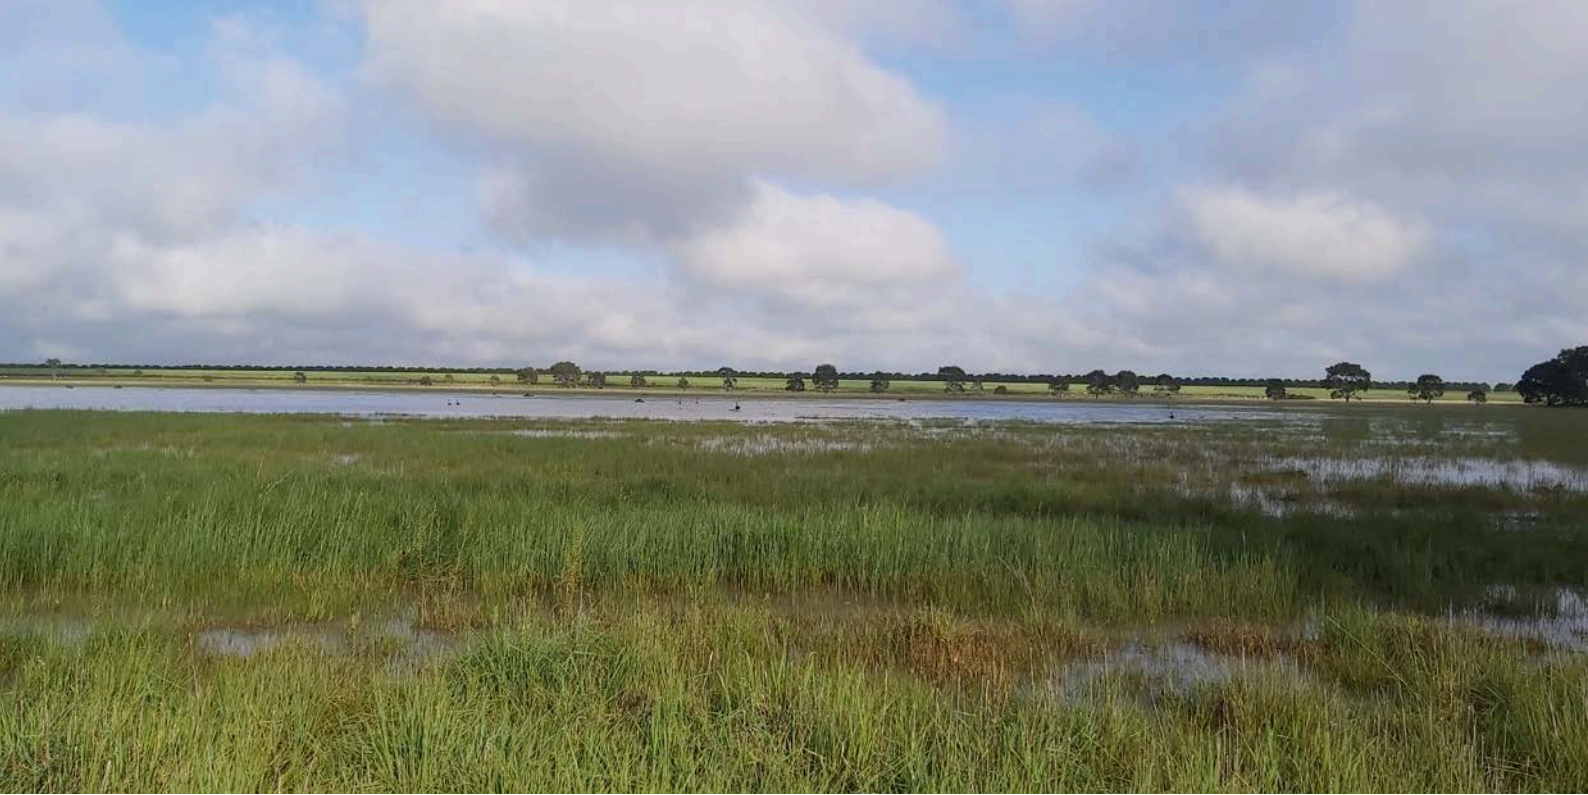
Photo 11. DUN003 Wetland (October 2022)

There were two drains sandbagged at the original sill height in Year 1, the sandbags placed in these drains are still working with no maintenance required.

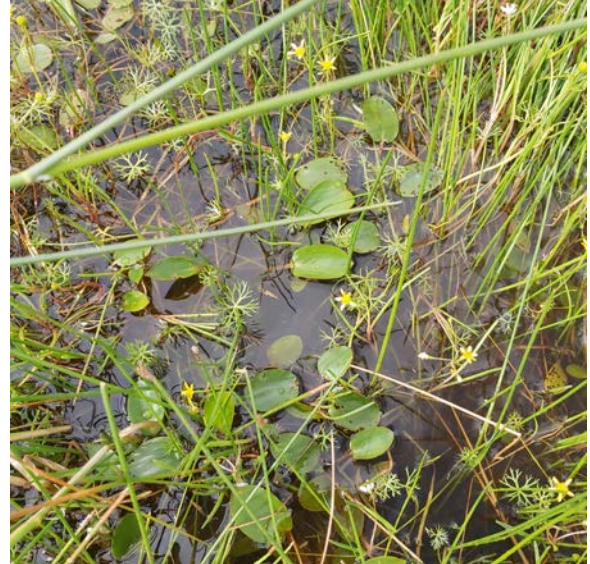
Photo 13: Aquatic forbs *Potamegeton*, *Ranunculus* and *Eleocharis*

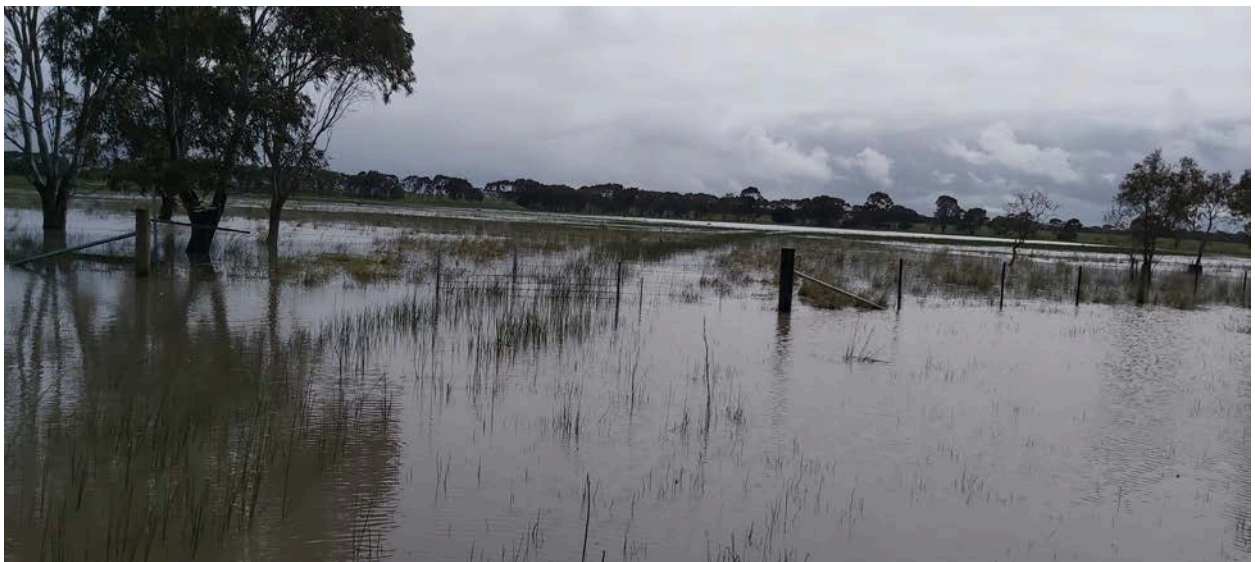
water depth, then up to 72% in September 2022. The basin reached a peak of 95% in October to 71.59% in November 2022.

Photo 14: Wetland reaching outside the fenced area into neighbouring paddocks (November 2022)

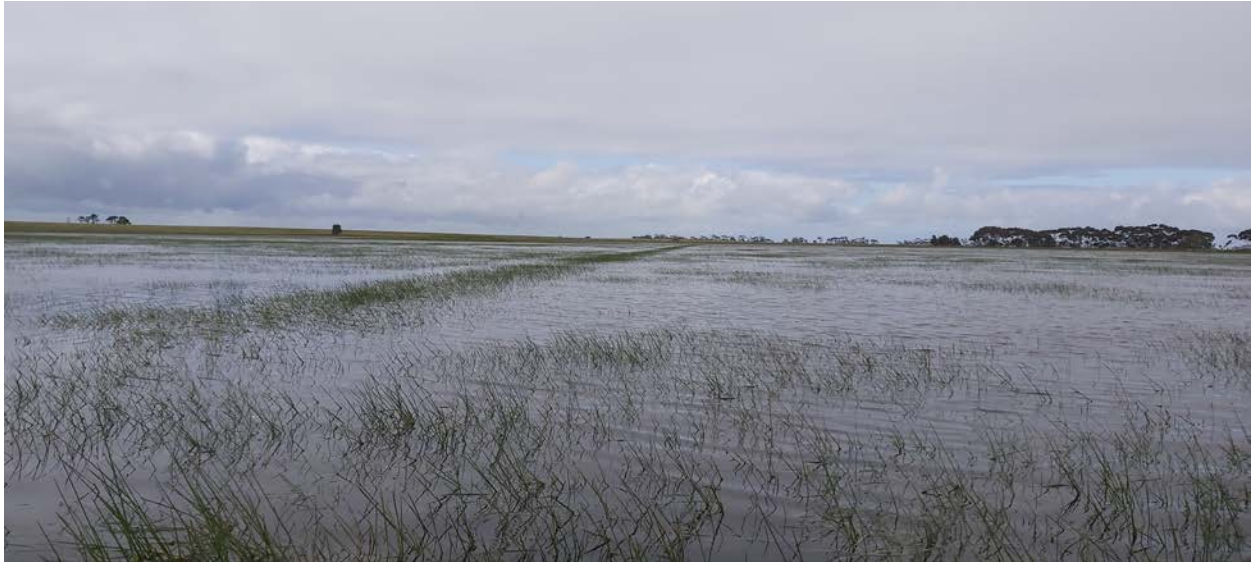
Sandbags were placed within the drain in Year 1 to allow for water levels to return to original sill height.. The sandbags were capped with geofabric sandbags prior to the wetland filling in Year 2 as the hessian bags had started to degrade.

Photo 16: Looking south over the wetland, Glyceria starting to emerge.

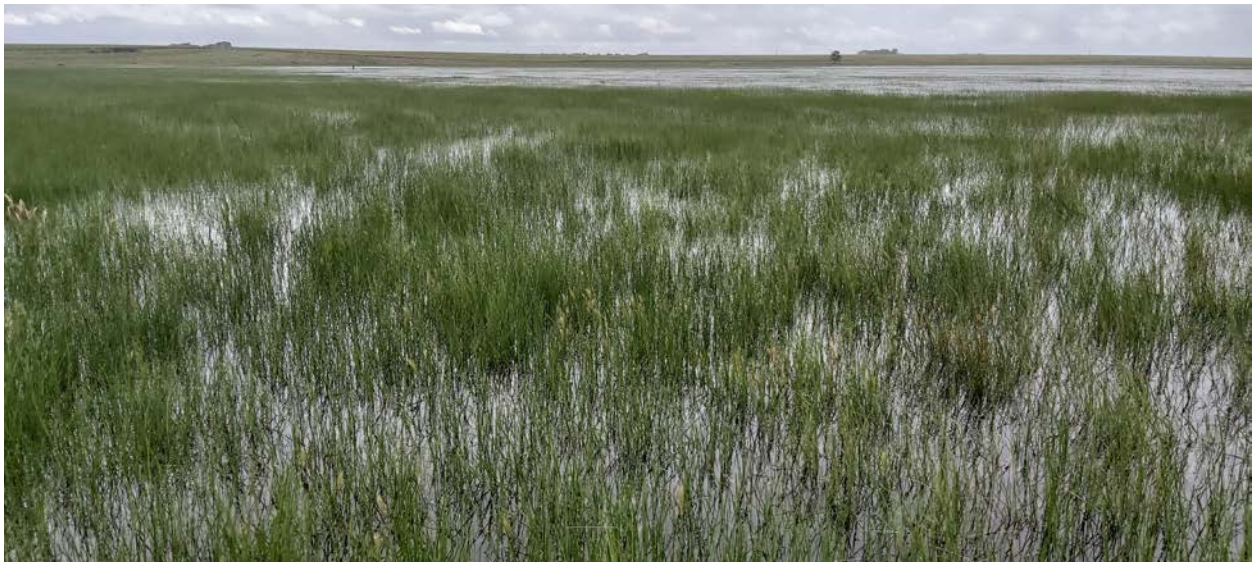
Photo 17: Emergent vegetation starting to grow Glyceria and Amphibromus (November 2022)
