Year 3 Evaluation
Wetlands Report

Dundonnell Brolga
Compensation Plan

9 December 2023

To provide the Year 3 wetland monitoring report as required by the endorsed Dundonnell Wind Farm Brolga Compensation Plan (BCP), under Condition 55b of Planning Permit No. 2015/23858.

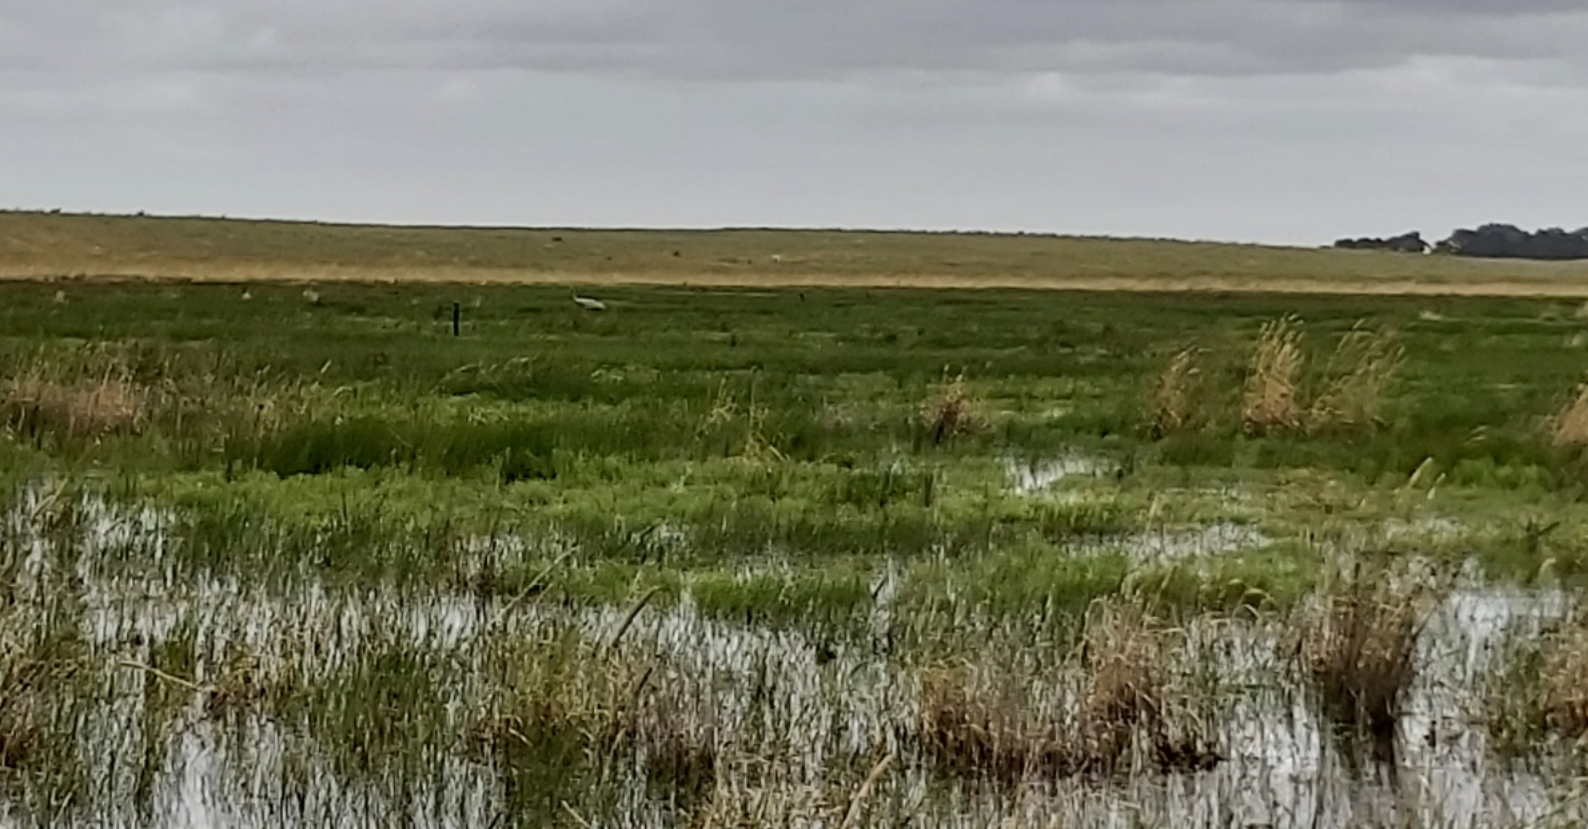
Photo. DUN001 – Wetland 15th December 2022 with Brolga

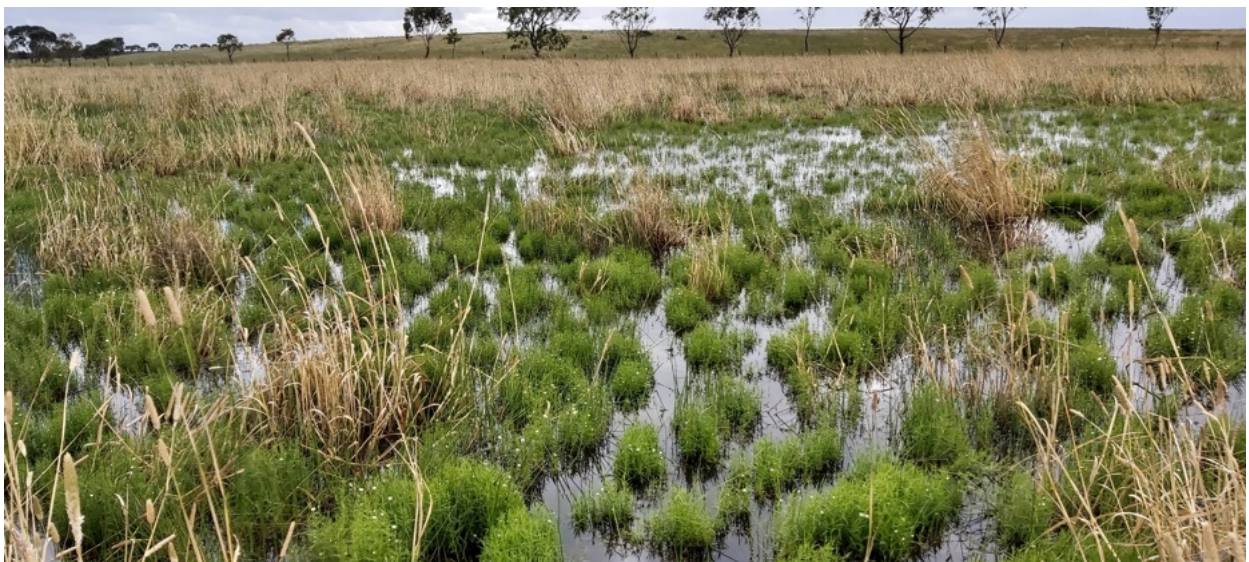
Photo. December 2022 *Phalaris* dieback from water inundation levels, *Stellaria angustifolia* (Swamp Starwort)

- Continue to undertake *Phalaris* management through selective grazing on the outer edges of the wetland (temporary electric fence set up to exclude stock from the middle section). Selectively spray *Phalaris* tussocks when wetland is dry in the middle section to reduce spread and increase native vegetation cover.

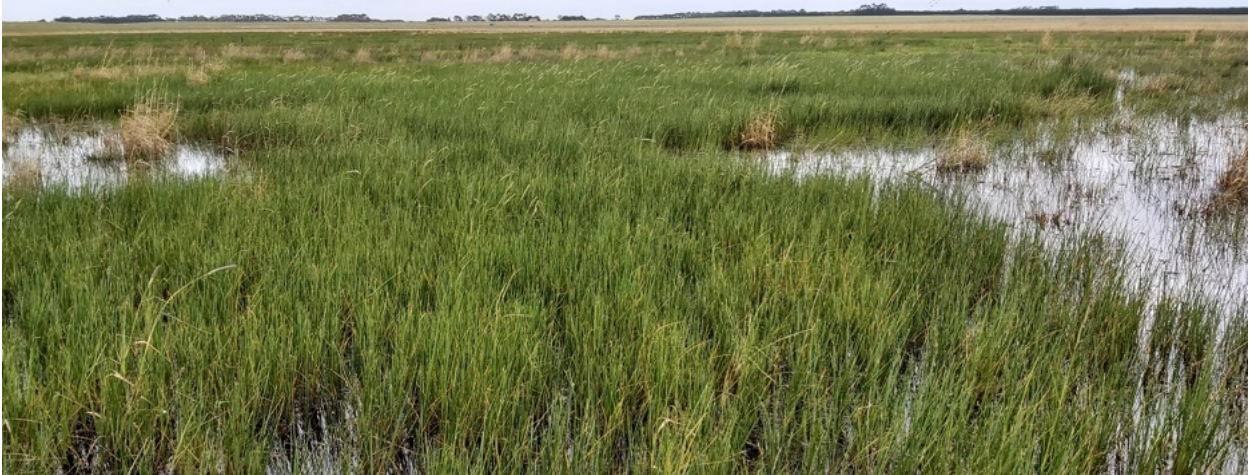
Photo. December 2022 *Phalaris dieback* and *Glyceria australis* (Australian Sweet-grass)

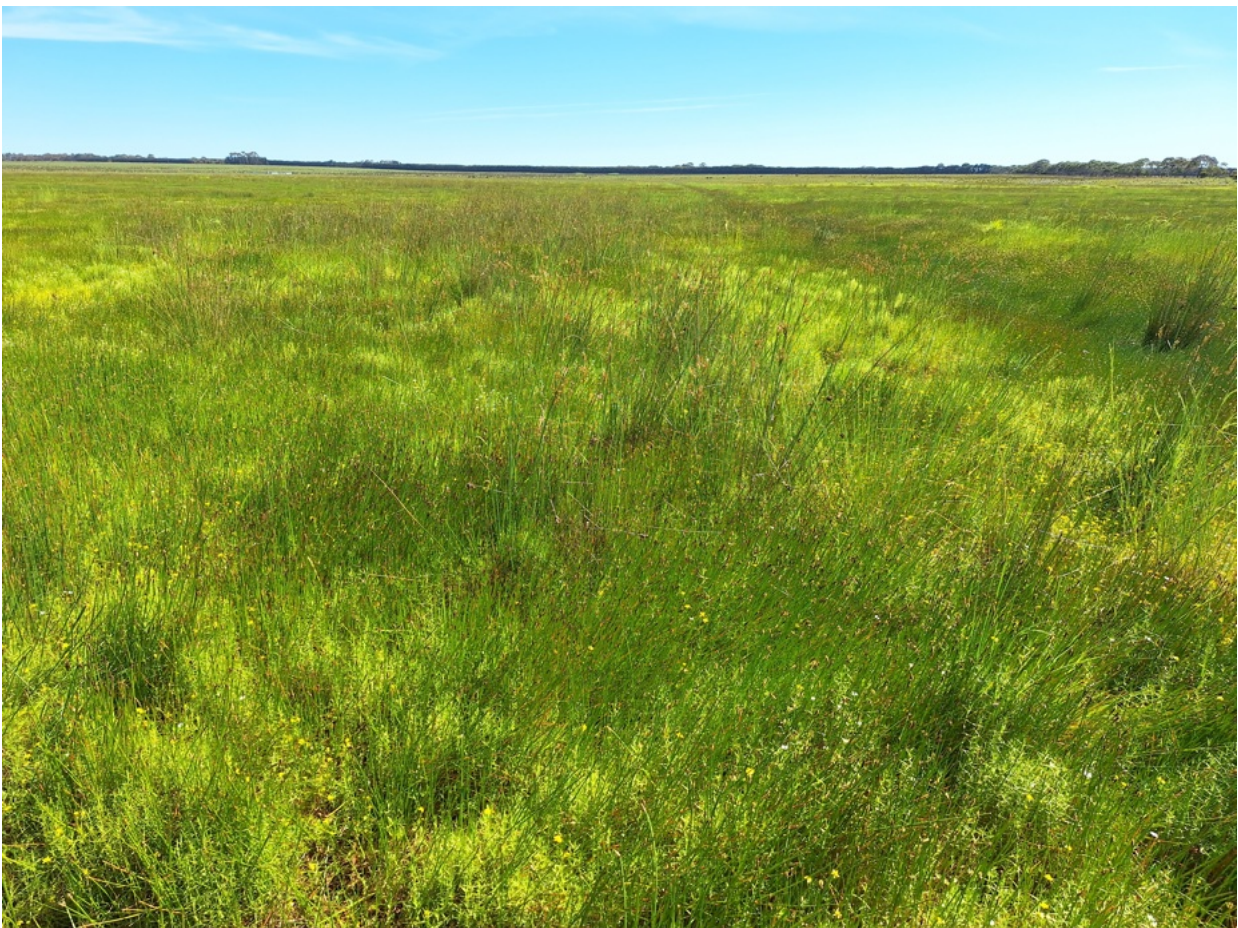
Photo. October 2023 channel area with a mix of native aquatic vegetation *Juncus*, *Eleocharis* and *Ranunculus* species

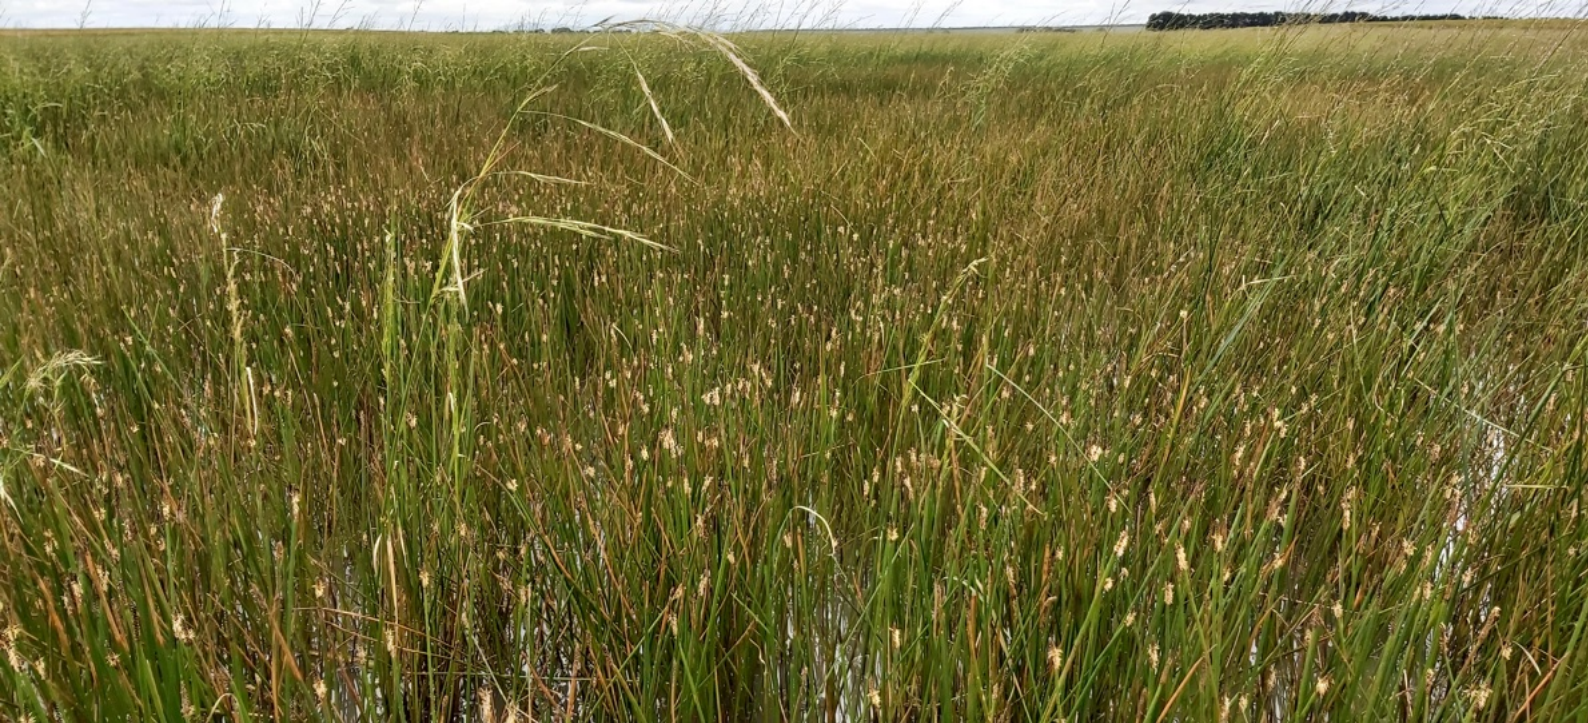
Photo. DUN002 Wetland 28th November 2022 with *Eleocharis acuta* (Common Spike-sedge) dominant in the foreground.

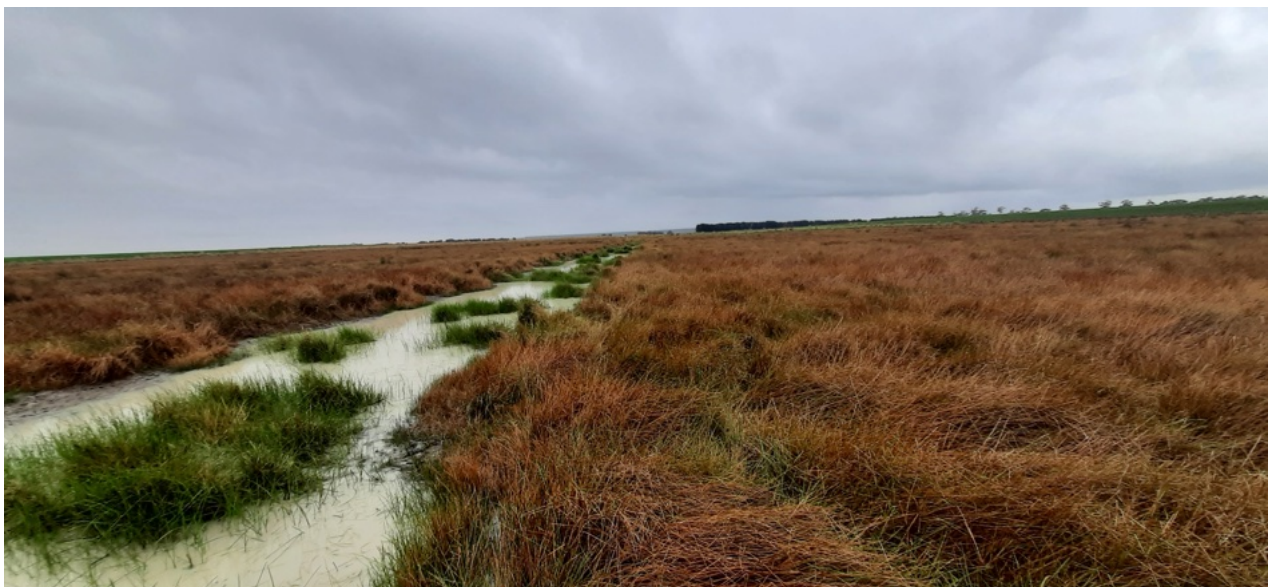
Photo. July 2023 with water in the drain, browning of *Eleocharis* across the site.

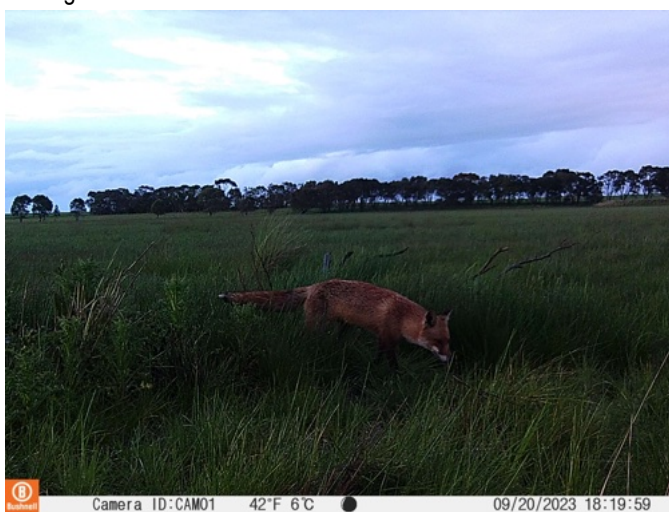
There were multiple photos of a fox recorded on the remote camera during the night and day (nine days in August, eight days in September and eleven days in October). The landholder has undertaken fox control through a shooting program, with two foxes shot during June 2023 prior to the breeding season.

Photo. *Vulpes vulpes* (Fox) captured on the remote cameras throughout the 2023 monitoring period.

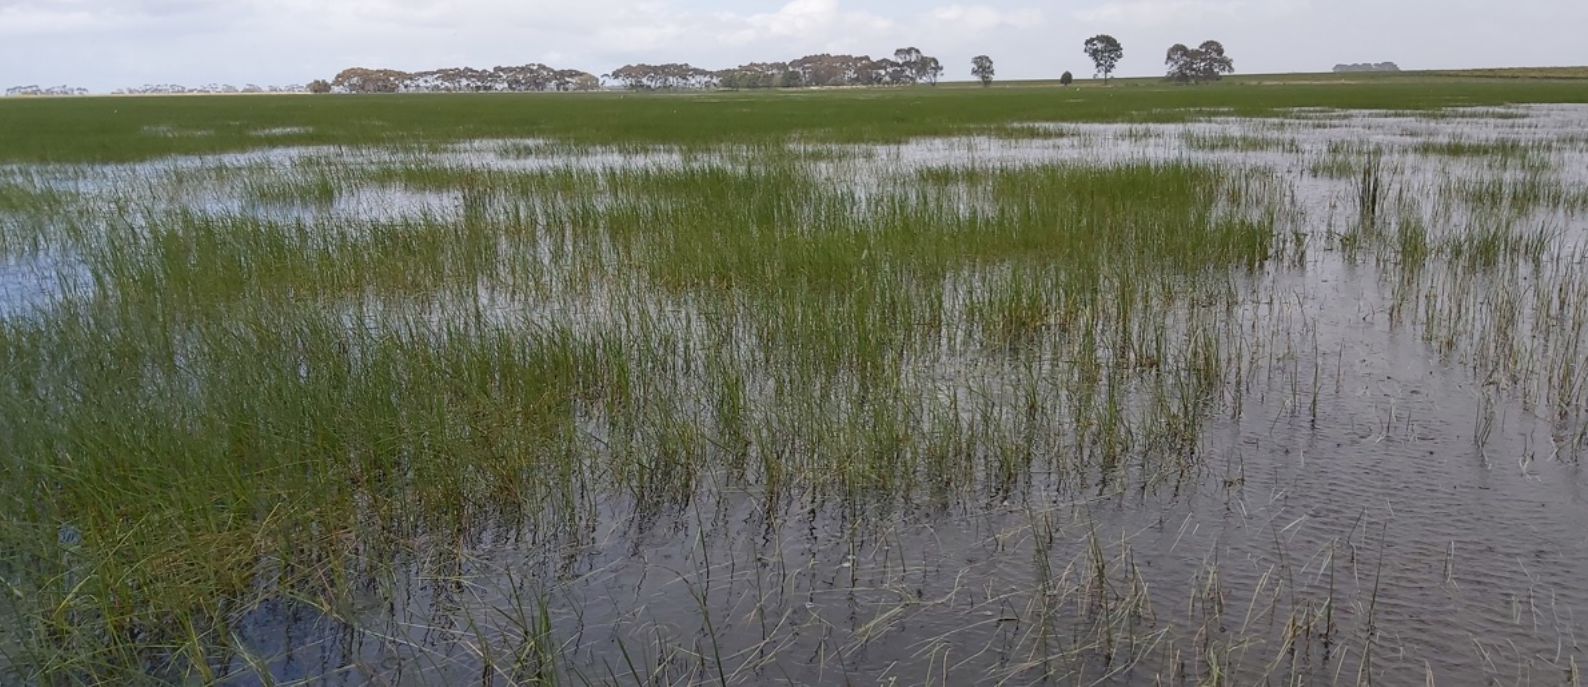
Photo. DUN004 Wetland 13th November 2022 with emergent aquatic native vegetation (*Glyceria australis* Australian Sweet-grass)

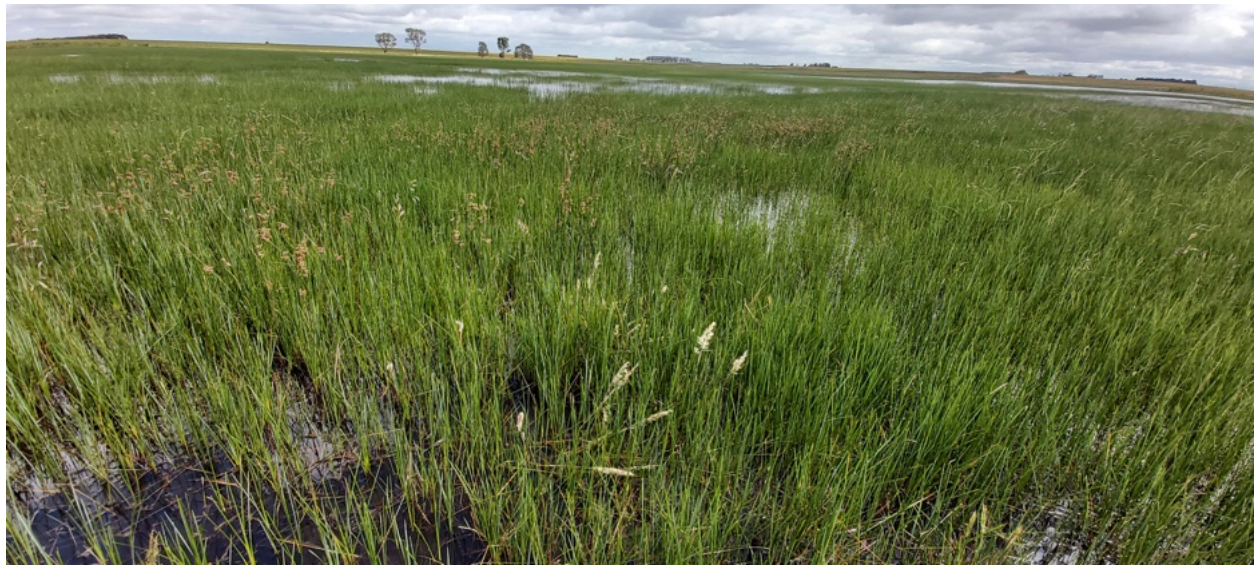
Photo. Native aquatic vegetation across the wetland including a mix of *Glyceria* and *Juncus* (28th November 2022)

- There is high biomass at site of native grasses (mainly *Glyceria australis*) from last seasons growth. Continue to monitor.

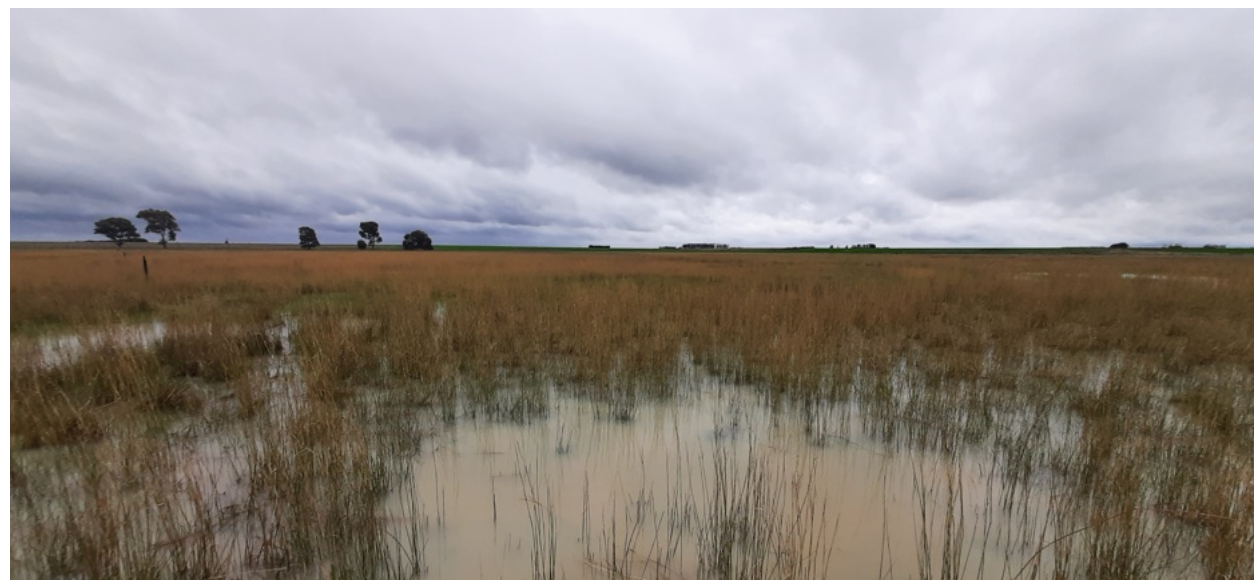
Photo. Wetland in July 2023 with *Eragrostis infecunda* (Southern Cane-grass) dominant in the middle section of the wetland.

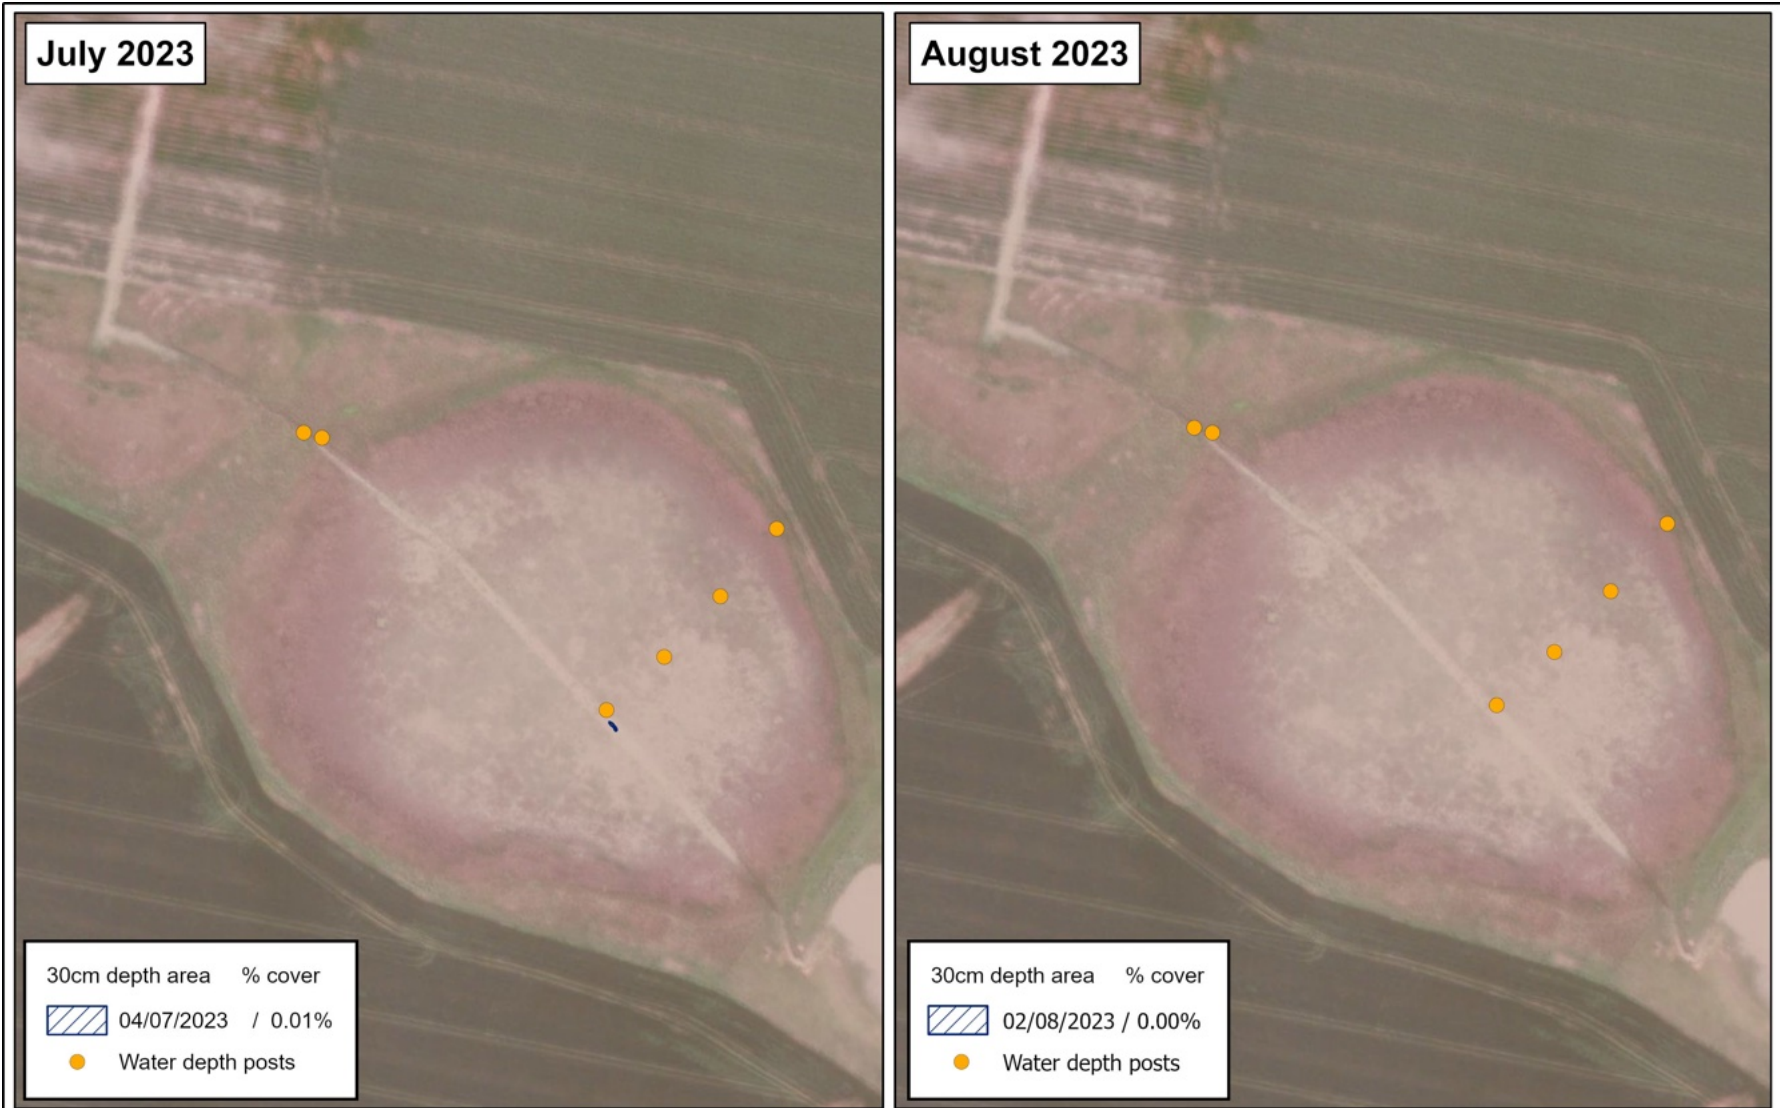
DUN-BCP-002 Cross Roads

Water depth and duration maps were modelled from the data collected from the fortnightly wetland extent marks and extracting values from the Digital Terrain Model (DTM – Lidar) to create a mean estimate of water heights to assist in determining if the wetland met the BCP performance target of 30cm coverage over 75% of the basin for a full Brolga breeding event (Jul-Nov).
